EXISTING BUILDING CONDITION SURVEY, WILBER HALL

SUNY OSWEGO
SCHOOL OF EDUCATION
OSWEGO, NY. 13126

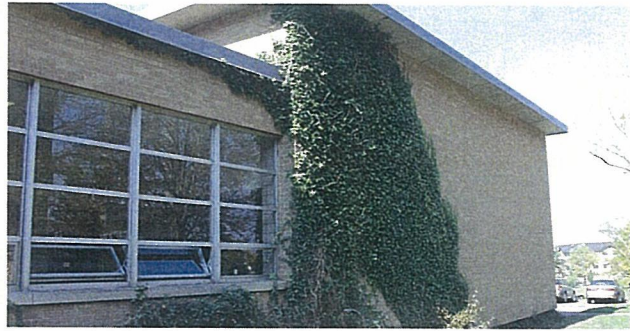
The brick exterior wall is in good condition. The interior corners at the recesses of the stair tower wall are missing mortar. The Fourth pier to the west from the stair tower at the three story wing is significantly cracked vertically from the ground to the roof it is bowing. The entry is in serviceable condition. The stone panels are uneven and are creating a tripping hazard. The third pier to the west has a slight vertical crack from the ground to approximately six feet above the grade. The end pier interior corner is cracked and missing mortar. There is an abandoned conduit line and there are holes in the brick nearby. The existing windows appear refinished. It is recommended that the stair tower wall interior corners be repointed, that the crack from the ground to the roof be investigated and the brick in this area possibly replaced, the canopy soffits be replaced and the landing stone be reset, a joint be installed at the third pier to the west, removal of the conduit and infilling of any holes, and replacement of the cracked sealant.

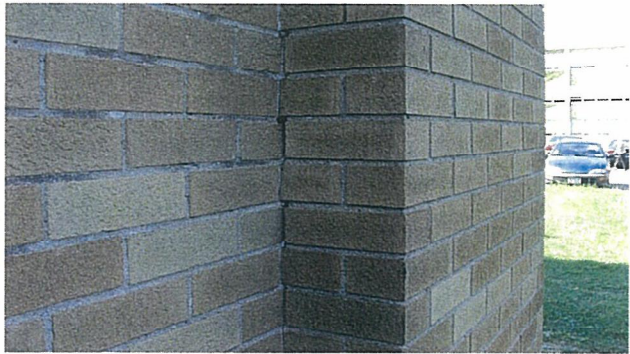
The brick wall is in good condition. The most northern pier has significant cracking at the outermost corner from the ground to approximately six feet above the ground. The most southern pier also shows cracking from the ground to the third floor. There are dead vines on the building face. A tree is growing at the foundation wall. There is significant vine growth on the wall. The existing windows appear to have been refinished. It is recommended that the broken brick and mortar be replaced, a joint at the inside corner of the pier on both inside corners be installed, vines on the building face and the tree near the foundation wall be removed, and the cracked sealant be replaced.

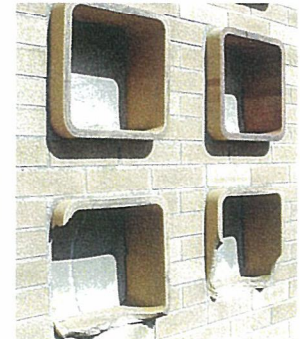
West Wall - Louver - South End

The brick is in good condition. The existing original windows appear to have been refinished. There are dead vines at the west end of the wall. The original louver infill is cracking. The fifth brick pier from the west is significantly cracked vertically and is bowed. The sealant is not holding, and as a result the crack widened. The corner of the fourth pier from the last has significant brick damage. The original existing louver infill is cracking at the south end and masonry has broken off. The third pier from the east is also cracked from the ground to the third floor. The area at the most eastern window is covered. There are two chillers at the grade with lines and service running up the building. It is recommended that cracked sealant at the windows and louvers be replaced, dead vines on the wall be removed, the original louver infill be replaced, the pier brick be removed, the issue identified, and the brick then replaced. It is also recommended that bricks at the corner of the fourth pier and the assembly including the original louver infill be replaced, perhaps with a window, and that the cause of the crack from the ground to the third floor at the third pier from the east be further investigated.

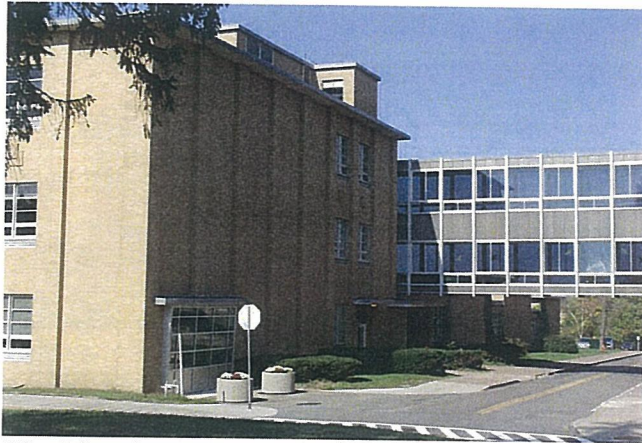
Wilber Hall - Bridge Link

The panels within the frames appear worn and two windows have failed. The surface beneath the bridge is heavily soiled. It is recommended that exterior panels and failed windows be replaced and the surface beneath the bridge be cleaned.

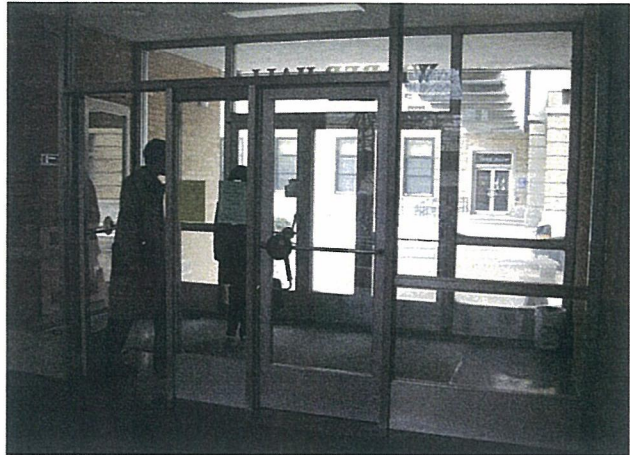
Wilber Hall - Exterior Doors

The exterior doors are the original clear anodized aluminum and single glazed doors that are non-insulated. They are also inappropriately sized with panic hardware and closers. There have been repairs through the years with bolts through the doors for additional hardware support and a wood stop replacing a missing aluminum stop. In the short term, a handicapped accessible entrance should be constructed, and the doors replaced with appropriately sized thermally broken handicapped accessible doors.

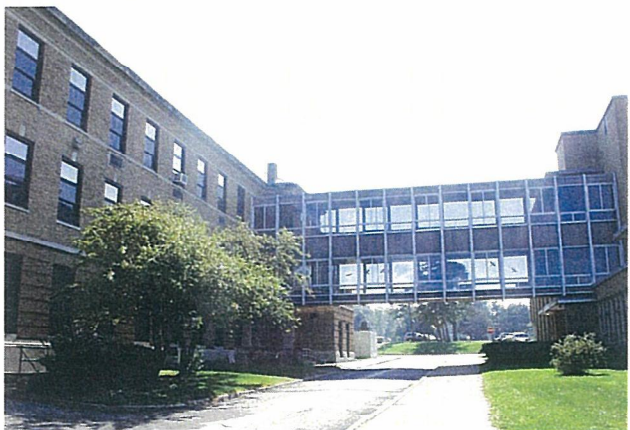
Wilber Hall -Bridge Link and Adjacent Site Conditions

The concrete/macadam walks, curb, and grassy areas are in serviceable condition. The flagstone porticoes and entries are non-handicapped accessible. The service driveway between Wilber and Park Halls becomes congested for students and bus drop-off, and breaks the unification of the buildings. In the short term, it is recommended that an entry be modified for a handicapped accessible means of access. Also, in the short term, it is recommended that the site be modified to enhance the unified School of Education.

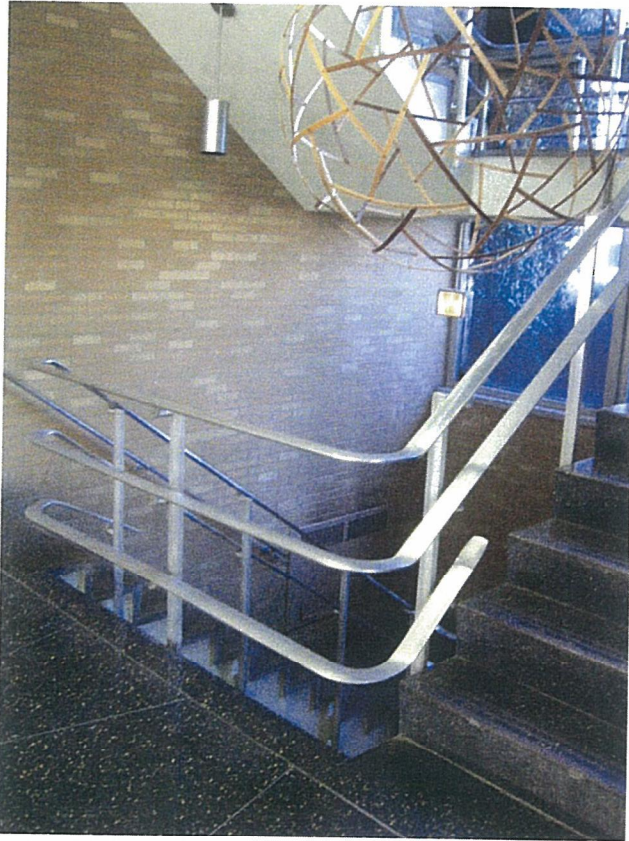
Wilber Hall - Central Stair

The stair treads and risers are pre-cast terrazzo and are in good condition with some wear and minor chipping at the nosings. The clear anodized railing system is in good condition, with some accessories missing. Clearances between horizontal and vertical members in the railing system are greater than 4".

There is a large nosing chip near the bottom of the stair. In the short term, it is recommended that the nosing be repaired to avoid injury.

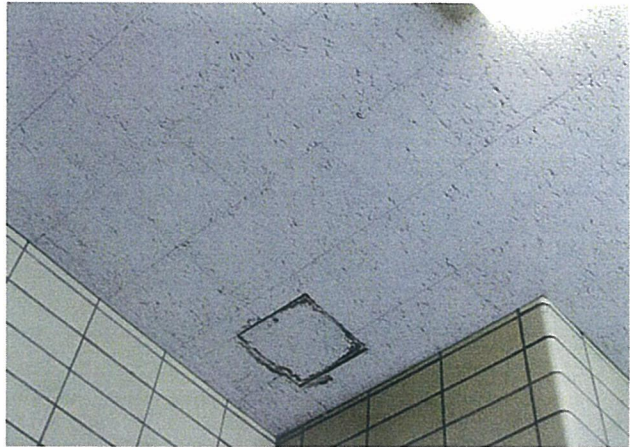
Wilber Hall - West Stair - Ceiling

The 1x1 z-spline ceiling system is in good condition with exception of the access panel tiles. The glazed CMU walls are in good condition. The third floor landing is a combination of 9x9 and 12x12 vinyl tiles that are in good condition. The rest of the landings are VCT and in poor condition. The railings are in good condition, they do not extend beyond the treads, and the clear distance between rails is greater than 4". More than half of the existing rubber treads have been replaced with newer rubber treads. In the short term, it is recommended that the landing floor finishes, the ceiling tile at the access panel, the treads, and the rubber tiles be replaced.

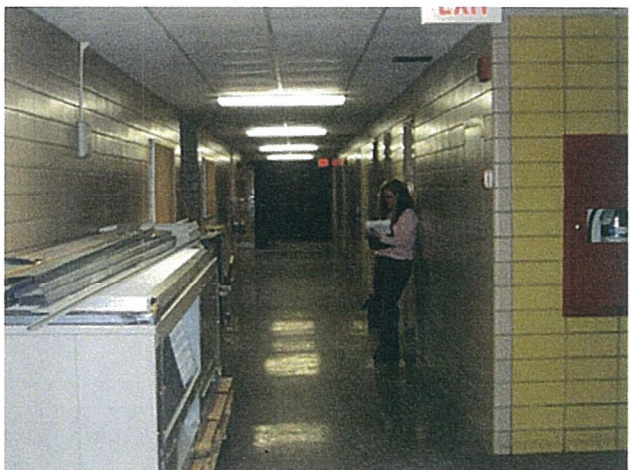
Wilber Hall - Basement

The ceilings are 2x2 APC with warped panels. In the short term, it is recommended that the ceiling be replaced.

The metal doors and frames are in good condition with some denting/chipping, and the room signage is no longer viable. In the short term, it is recommended that the metal doors be repaired and painted, and the signage be replaced.

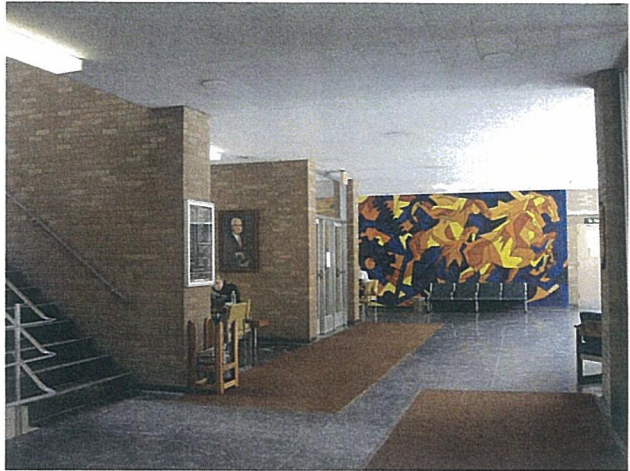
Wilber Hall - Main Lobby

There are z-spline ceilings with areas of replacement through the years. The area of ceiling between the open stair and east exterior doors is significantly warped, and the soffited ceiling at the fire doors is in poor shape. In the short term, it is recommended that the ceiling tile in the Main Lobby and fire door soffited areas be replaced.

There are z-spline ceilings with areas of replacement through the years. The replacement tiles are very noticeable because they are whiter and not secured properly. Some of the replacement tile corners are very badly chipped. In the short term, it is recommended that the entire ceiling system be replaced, or, replace broken/chipped ceiling tile, set properly, and paint with an appropriate acoustic panel paint for a uniform finish.

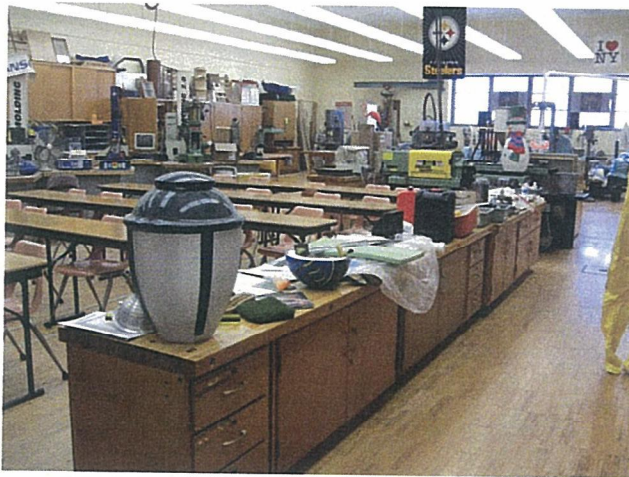
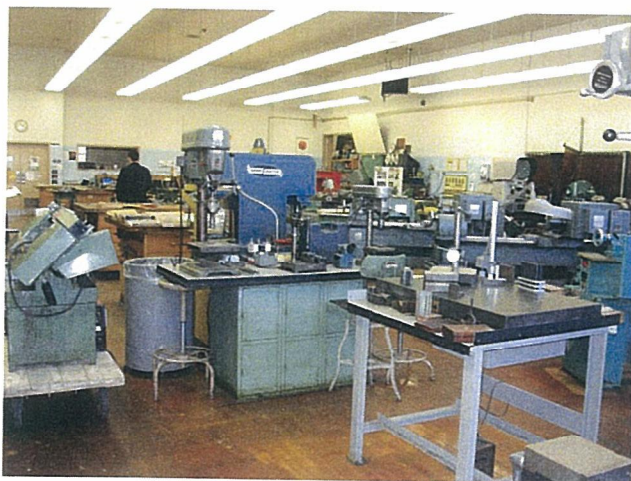
Wilber Hall - Room 0160 and 0163 Labs

The 1x1 z-spline ceilings, CMU walls, and wood floors are in good shape. In the short term, it is recommended that the wood floors be refinished and walls painted.

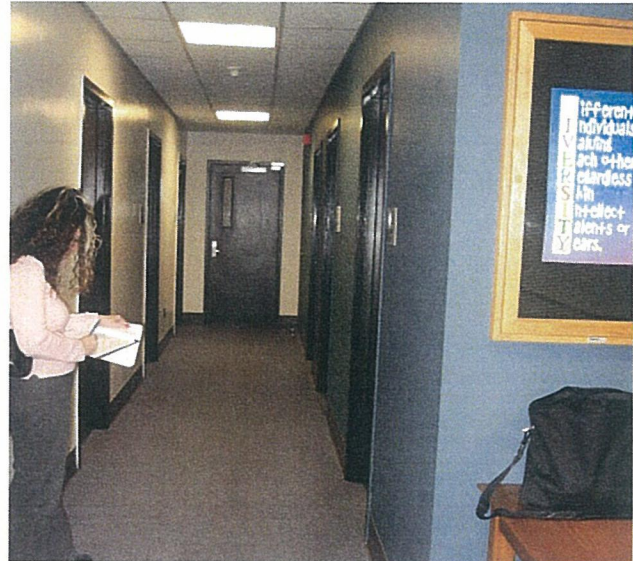
Wilber Hall - Room 250 - Office Suite

The 2x2 APC tiles are sagging, the carpet is warped with raised seams, and the wall at the electric panel within the suite hallway is cracking in two areas. The plaster and GWB walls are generally in good condition. The metal doors and frames are in good condition, although the paint is chipping. In the short term, it is recommended that the ceiling system and carpet be replaced, the crack in the wall repaired, and the doors and frames be painted.

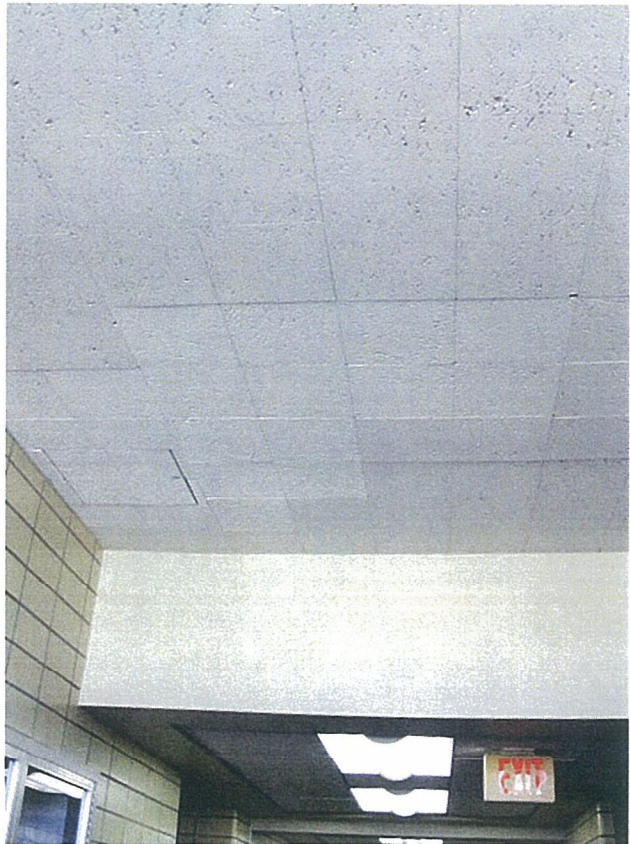
Wilber Hall - Third Floor Corridor

Most of the ceiling is a new GWB soffited ceiling with new hung 2x2 APC. At the elevator, the existing 1x1 z-spline ceiling was not replaced, areas of patch here are not installed properly, and the ceiling grid support angle paint here at the east wall is peeling. There is water damage at the new GWB soffit near the double fire doors. In the short term, it is recommended that the existing ceiling at the elevator and water damaged GWB soffit be replaced.

The terrazzo floor is in good condition, with some chipping at the joints, and significant cracking at the fire door. In the short term, it is recommended that the terrazzo at the fire door be replaced and a threshold installed due to significant cracking at the floor.

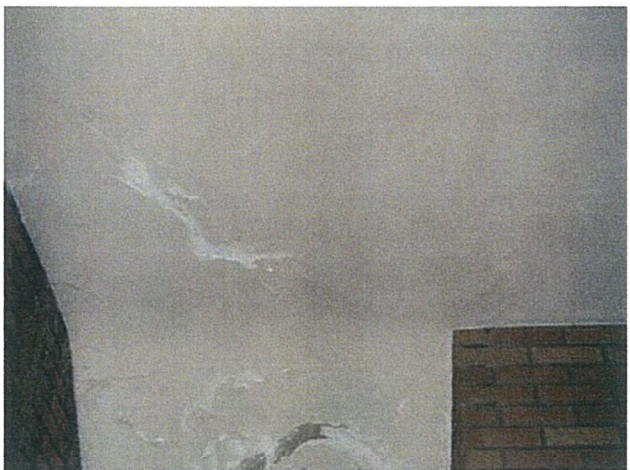
Wilber Hall - Penthouse Water Damage

The stair ceiling to the penthouse is plaster and has significant water damage. The terrazzo stair is in good condition, with some cracking at the joints. The railing near the penthouse mechanical room door is loose and the stair landing has a large crack in the floor near the railing. In the short term, it is recommended that the water damaged ceiling be replaced, the loose railing be secured, and the landing be repaired.

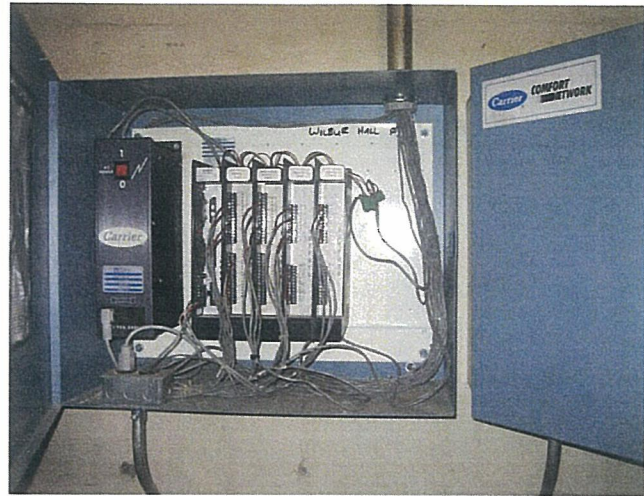
Wilber Hall - Pneumatic System

The majority of the building is served by pneumatic controls. The pneumatic system is mostly original. Direct digital controls (DDC) have been overlaid to control newer equipment and certain time-clock functions of the original system. The controls provided as part of the original construction have reached the end of their normally anticipated useful service lives.

In the short term, it is recommended that the controls be inspected and serviced frequently in an effort to maintain reliable operation with limited downtime due to failures despite their age. In the long term, it is recommended that the conversion from pneumatic to DDC be continued as the equipment being controlled is replaced.
