STATE UNIVERSITY OF NEW YORK AT OSWEGO

WEST CAMPUS DINING HALL
BUILDING SHELL IMPROVEMENTS

FEASIBILITY STUDY ■ MAY 10, 2011

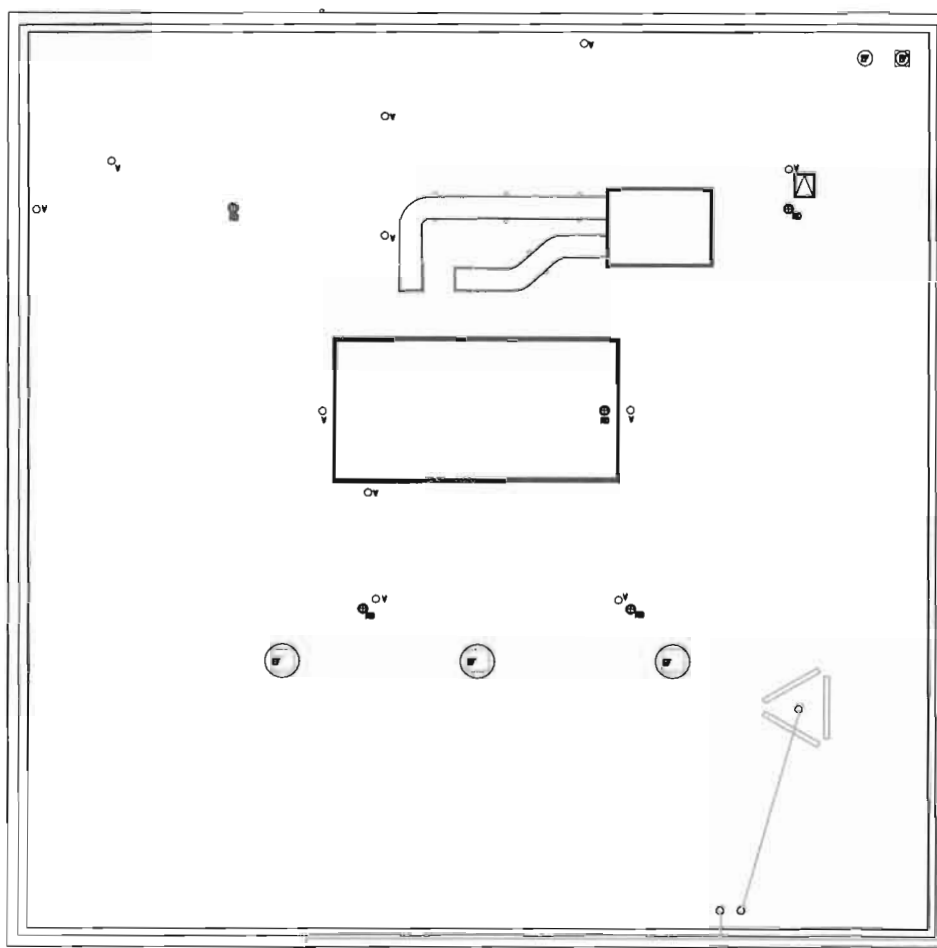
PATHFINDER ROOF

Multiple patches and evidence of previous repairs were observed. Building staff indicated that interior leaks have been reported.

Drains were generally clear with adjacent tapered insulation crickets providing some drainage; however, large areas of water ponding was evident below mechanical equipment. One of the roof drains was missing a strainer cover. (See Photo R-31-05).

Walkway pads are missing and others are freely blowing in the wind.

Parapet membrane flashings around the roof perimeter are in poor condition, and have failed in numerous locations.

Lack of positive membrane adhesion to the insulation boards is evident. During the inspection, membrane flutter was observed over several large areas.

The taper substrate is questionable at multiple locations under foot, suggesting that the insulation boards have been exposed and/or are wet. The membrane lacks a positive bond to the insulation board in multiple locations and was observed fluttering during the inspection.

The metal top and sides of the large metal ventilation duct plenum on the roof are heavily rusted. (See Photo R-31-06).

Base flashing around the perimeter of all roof penetrations are showing signs of deterioration.

The lack of membrane bond and extensive wind fluttering is a concern. Numerous nail holes, rips and tears in the membrane are possible sources of water entry. Perimeter terminations need to be replaced. Large areas of ponding indicate poor drainage and remain a risk for water entry.

It is recommended that membrane and roof assembly be removed to the vapor retarder and replaced. Replace existing roof drain strainers with lockable type or cast iron to reduce the risk of blow off. Replace walkway pads with fully bonded pads and add walk pads below equipment and wiring currently draped across the membrane surface.

- Closely inspect the roof, particularly the parapet membrane flashings around the roof perimeter, and repair and reinforce existing tears, nail punctures, tents, splits, and seams judged to be inadequate.

We recommend careful inspections of the roof every three or four months until the roof can be replaced.

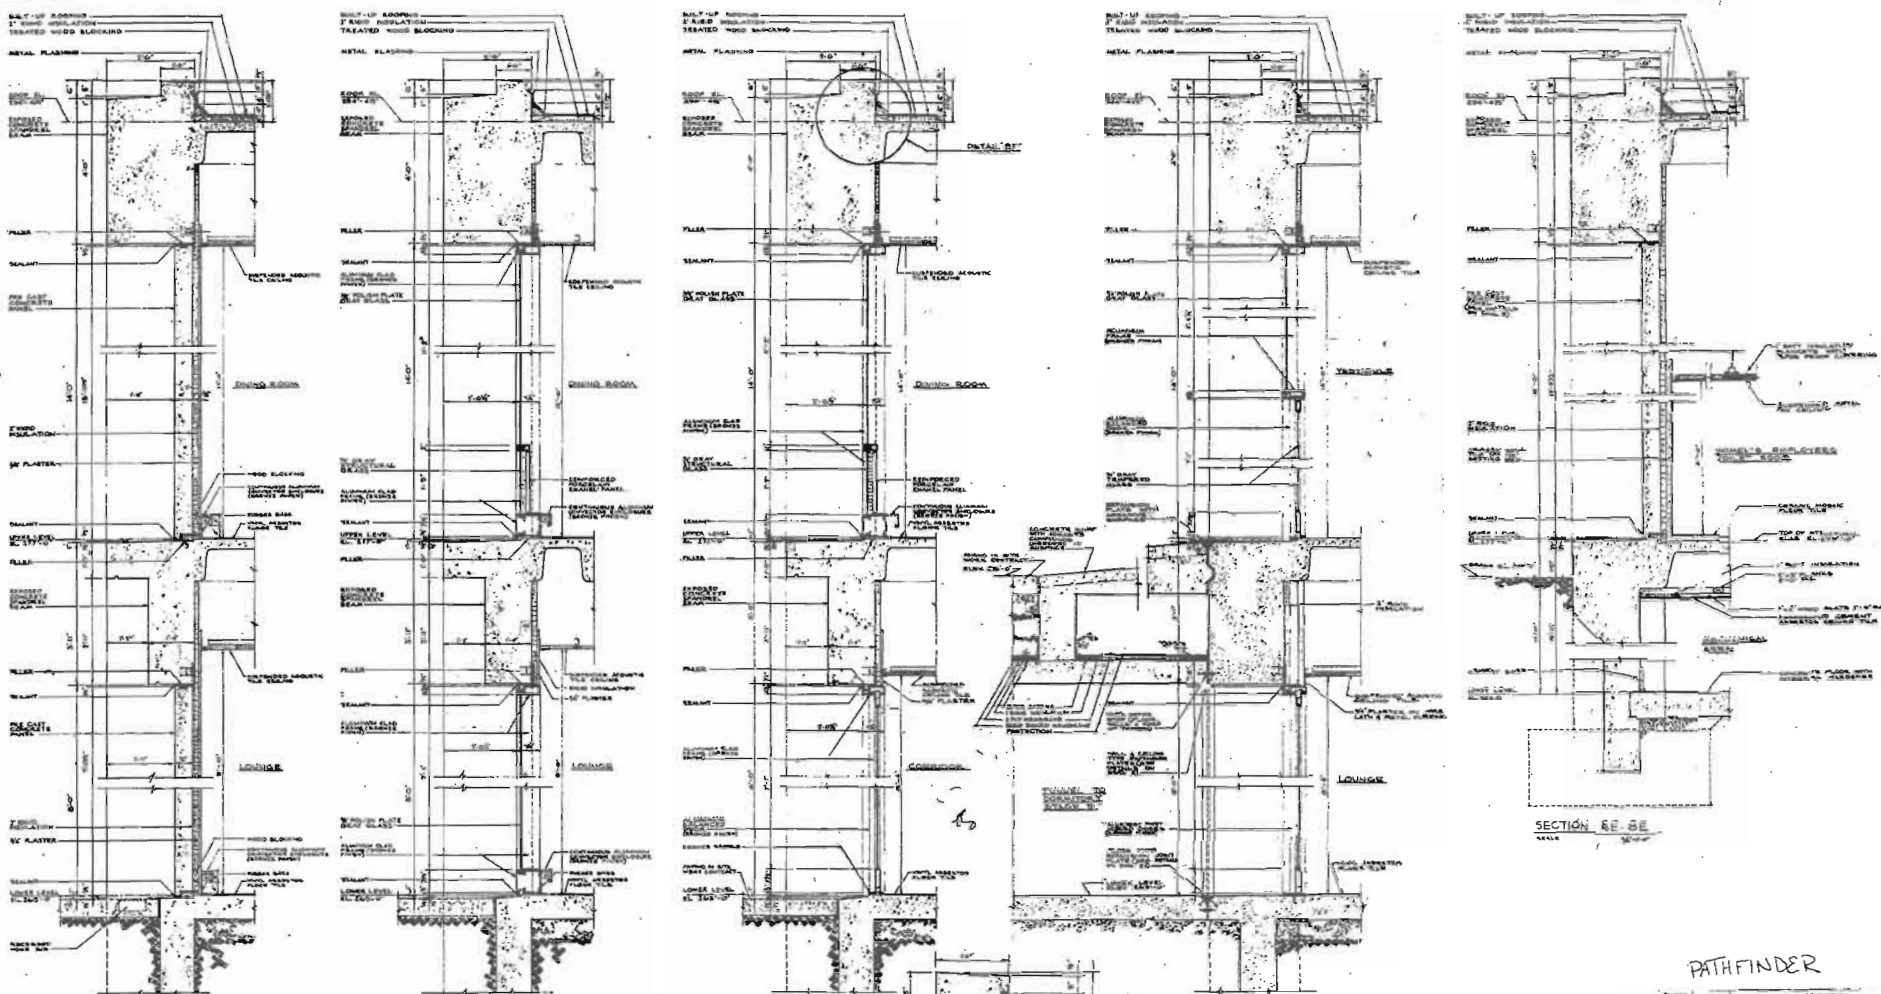
DETAIL 'BF' (TYPICAL PARAPET FLASHING)
SCALE: 1/4" = 1'-0"

The parapet has a cold construction joint running horizontally through it, at the roof slab elevation. This has apparently been a location of flexure and/or moisture mitigation that has resulted in a line of cracking and distress.
