EXISTING BUILDING CONDITION SURVEY, WILBER HALL

SUNY OSWEGO
SCHOOL OF EDUCATION
OSWEGO, NY. 13126

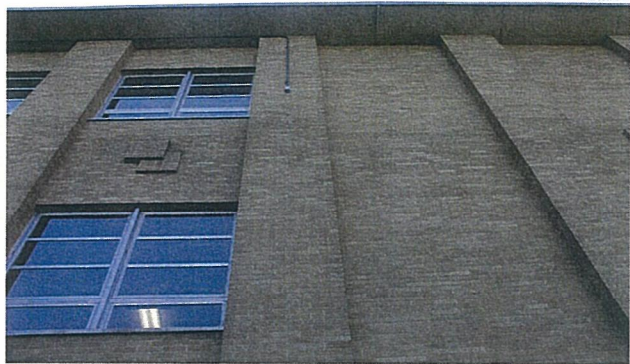
Wilber Hall - North Wall - Fourth Pier to the West

The brick exterior wall is in good condition. The interior corners at the recesses of the stair tower wall are missing mortar. The Fourth pier to the west from the stair tower at the three story wing is significantly cracked vertically from the ground to the roof it is bowing. The entry is in serviceable condition. The stone panels are uneven and are creating a tripping hazard. The third pier to the west has a slight vertical crack from the ground to approximately six feet above the grade. The end pier interior corner is cracked and missing mortar. There is an abandoned conduit line and there are holes in the brick nearby. The existing windows appear refinished. It is recommended that the stair tower wall interior corners be repointed, that the crack from the ground to the roof be investigated and the brick in this area possibly replaced, the canopy soffits be replaced and the landing stone be reset, a joint be installed at the third pier to the west, removal of the conduit and infilling of any holes, and replacement of the cracked sealant.

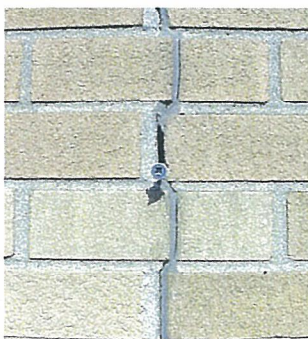
Wilber Hall - West Wall - Fifth Brick Pier

The brick is in good condition. The existing original windows appear to have been refinished. There are dead vines at the west end of the wall. The original louver infill is cracking. The fifth brick pier from the west is significantly cracked vertically and is bowed. The sealant is not holding, and as a result the crack widened. The corner of the fourth pier from the last has significant brick damage. The original existing louver infill is cracking at the south end and masonry has broken off. The third pier from the east is also cracked from the ground to the third floor. The area at the most eastern window is covered. There are two chillers at the grade with lines and service running up the building. It is recommended that cracked sealant at the windows and louvers be replaced, dead vines on the wall be removed, the original louver infill be replaced, the pier brick be removed, the issue identified, and the brick then replaced. It is also recommended that bricks at the corner of the fourth pier and the assembly including the original louver infill be replaced, perhaps with a window, and that the cause of the crack from the ground to the third floor at the third pier from the east be further investigated.

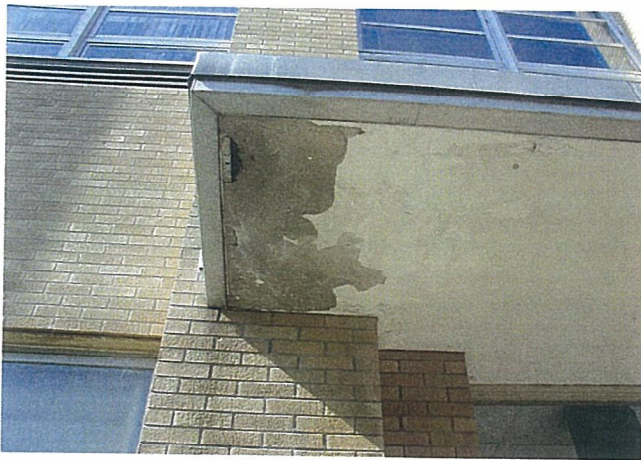
Wilber Hall - East Wall - Entry Soffit

The brick wall is in good condition. The existing original windows appear to have been refinished. The entry soffit near the elevator is damaged at the southern corner. The doors here are old, rusty and difficult to use. The main Wilber Hall entry canopy soffit is damaged at the southern and northern corners. The entry landing slate stone panels are no longer level and are significantly chipped. It is recommended that cracked sealant be replaced, the entry soffits near the elevator be repaired, holes in the wall at this entry be infilled, the doors be replaced, the main Wilber Hall entry canopy soffits be repaired and the entry landing slate stone panels be replaced.

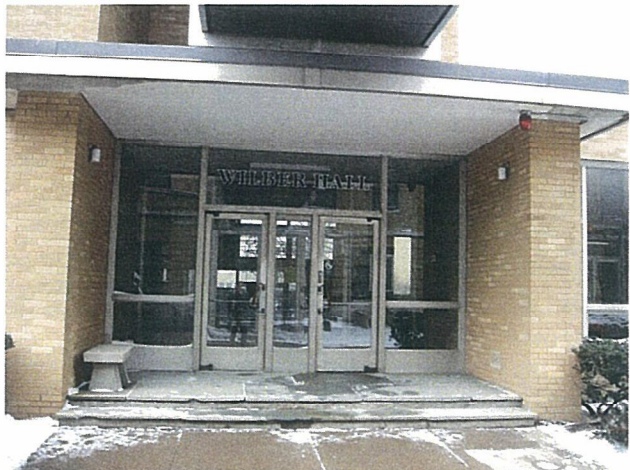
Wilber Hall - Exterior Doors

The exterior doors are the original clear anodized aluminum and single glazed doors that are non-insulated. They are also inappropriately sized with panic hardware and closers. There have been repairs through the years with bolts through the doors for additional hardware support and a wood stop replacing a missing aluminum stop. In the short term, a handicapped accessible entrance should be constructed, and the doors replaced with appropriately sized thermally broken handicapped accessible doors.

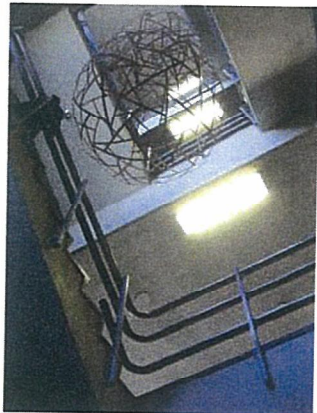
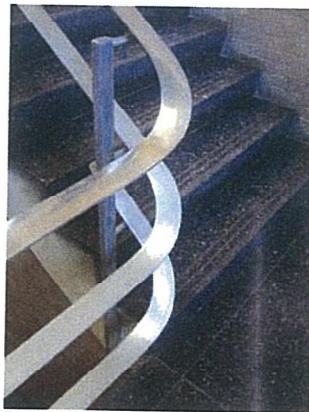
Wilber Hall - Central Stair

The stair treads and risers are pre-cast terrazzo and are in good condition with some wear and minor chipping at the nosings. The clear anodized railing system is in good condition, with some accessories missing. Clearances between horizontal and vertical members in the railing system are greater than 4".

There is a large nosing chip near the bottom of the stair. In the short term, it is recommended that the nosing be repaired to avoid injury.

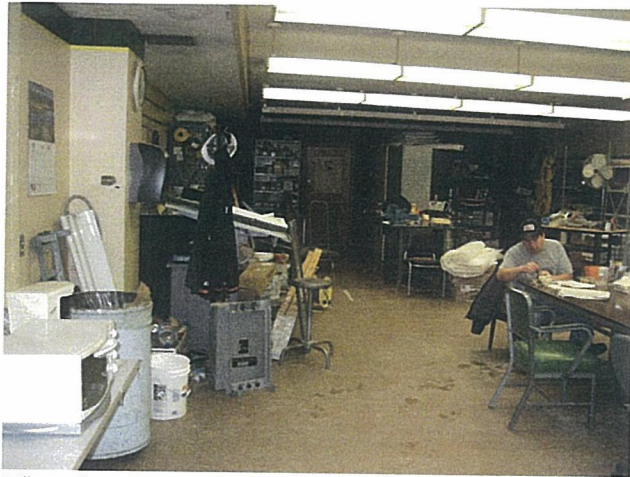
Wilber Hall - Room B-3

The 1x1 z-spline ceiling is in good condition, with the east wall support angle short of the tile. The walls are plaster/GWB and the floors are 9x9 vinyl tile in good condition. In the short term, it is recommended that the ceiling tile be cleaned, a wider ceiling angle be installed, and the cork wall at the south end of the room be removed/replaced.

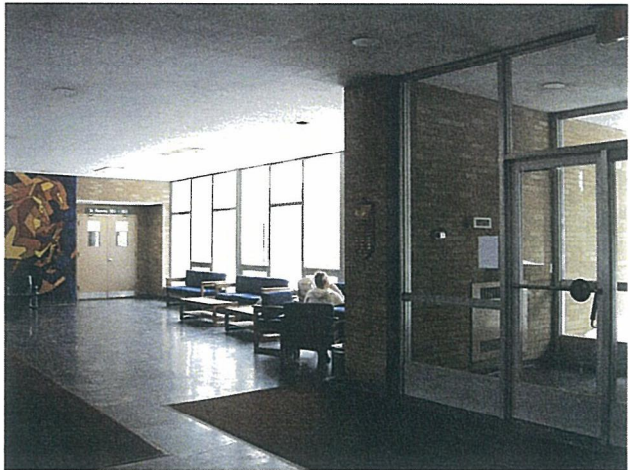
Wilber Hall - Main Lobby - Doors

The fire doors show much wear with dings and dents and the hardware is not handicapped accessible. In the short term, it is recommended that the doors be repaired and the hardware be replaced with handicapped accessible hardware.

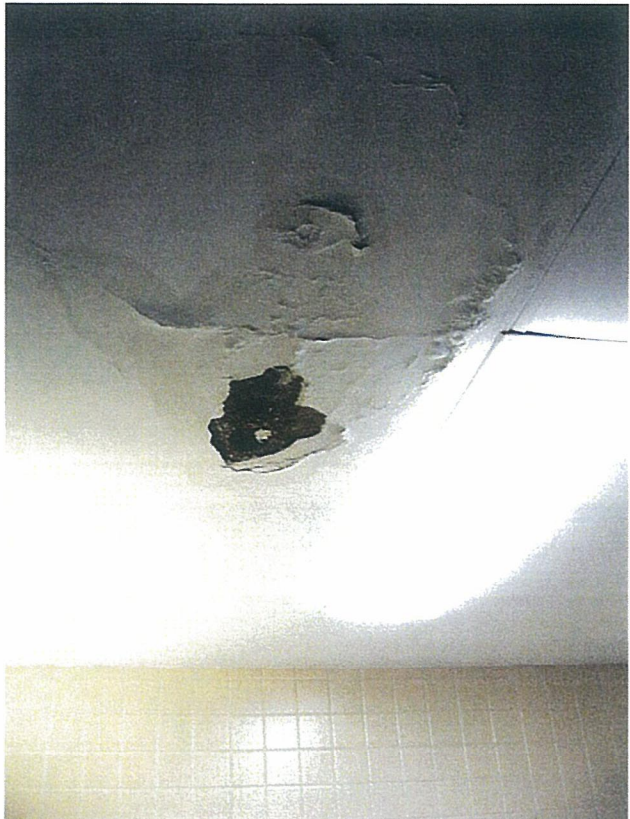
Wilber Hall - Men's Toilet Third Floor - Ceiling

The Men's Toilet room has a CMT floor, full CT walls, and marble stalls that are in good condition. The rusty water damaged hung ceiling system and wood veneer stall doors are in poor condition and there are no handicapped accessible accommodations. In the short term, it is recommended that the ceiling system and wood veneer stall doors be replaced, and a handicapped accessible stall and fixtures be provided.

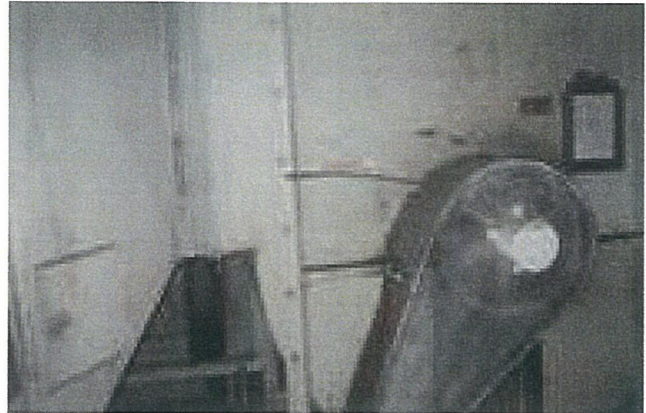
Wilber Hall - Exhaust Fan

Due to the original program of labs and shops requiring fume and odor control, the percentage of the building exhausted is higher than typical for a typical academic building. Although the various exhaust systems remain functional, it appears programs have changed and may continue to change such that modifications of the exhaust systems may be warranted based on revised needs for fume control and/or a possible energy savings associated with reductions in exhaust air needs. Further, the exhaust fans exceeded their normally anticipated useful service lives.

In the short term, it is recommended an overall review of the exhaust system arrangements and their air balance be analyzed against the current room use to ensure proper fume control is being provided for all spaces. In the long term, it is recommended that the entire system be reorganized concurrent with a major renovation project. At that time, the economic feasibility of recovering energy from the exhaust air to pre-treat incoming air should be evaluated. Should a major renovation not occur, it is recommended that the exhaust fans be scheduled for eventual replacement due to their age.

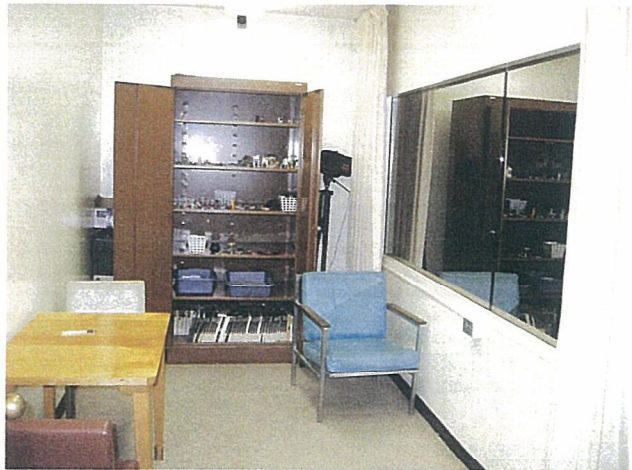
Mahar Hall, Typical Finish/Lifespan

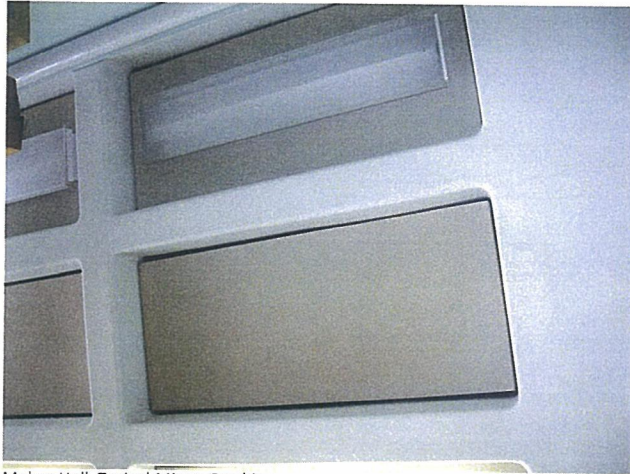
Mahar Hall, Typical Minor Cracking

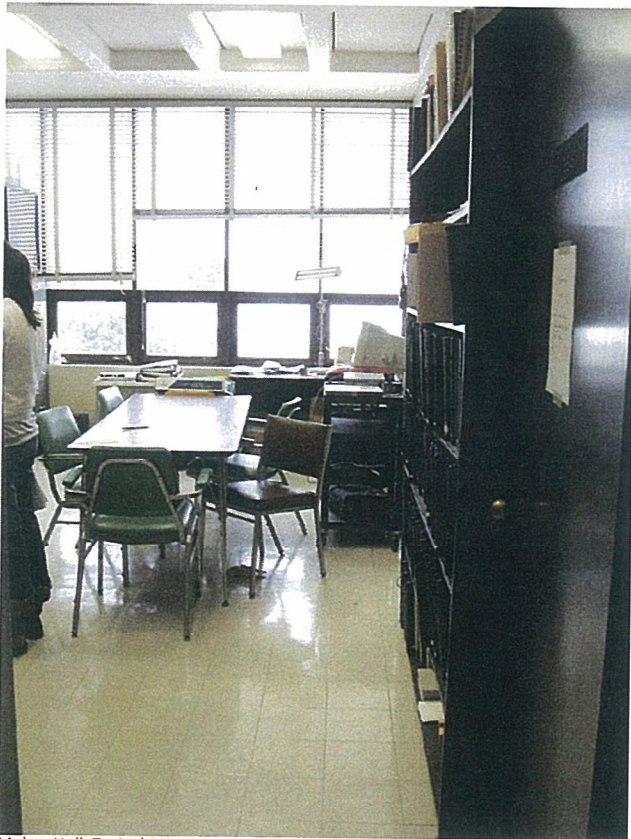
Mahar Hall, Typical Minor Water Damage

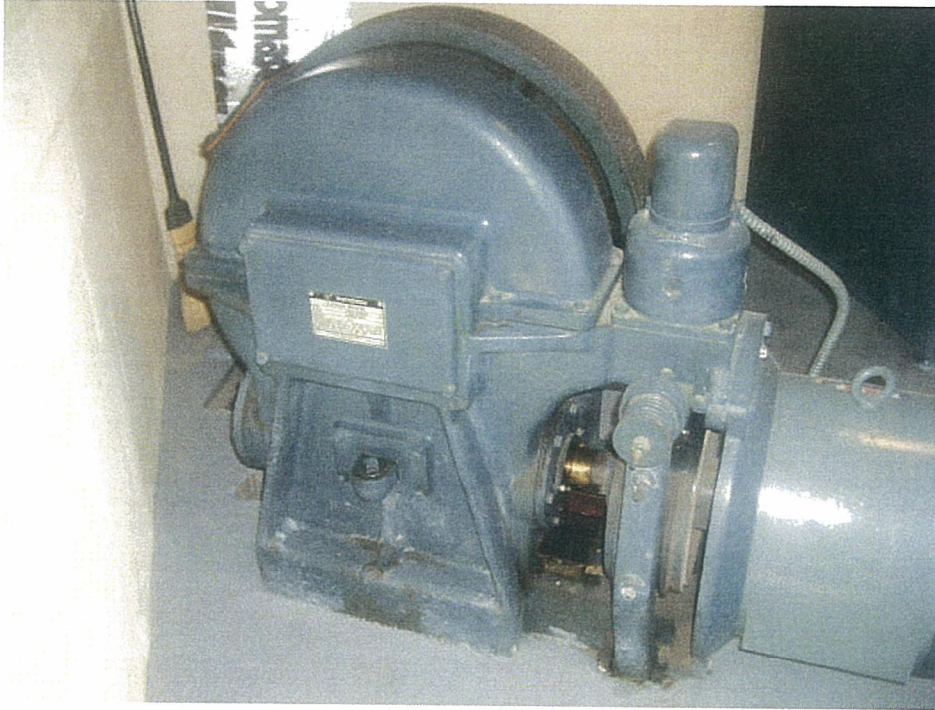
Westinghouse
Overhead Traction
machine

The existing hoist motor was repaired by Auburn Armature about 5 years ago; likely it was just re-wound to extend its lifespan. The machine currently appears to be in good working order. Although the equipment appears to be acceptable for the short term, a loss of a major component within the worm gear would likely cause a significant down time for repairs. Due to the age of the equipment a replacement of the hoist machine and motor at the time of controller replacement is recommended. It is likely that an increase in the current 75 Foot per Minute (FPM) hoist machine could be increased to 150 FPM. Due to the current travel distance of about 41 ft. an increase in car speed should be considered if the elevator is to be used for passenger service. The hoist cables appear to require inspection at this time and replacement when the machine is replaced is recommended.

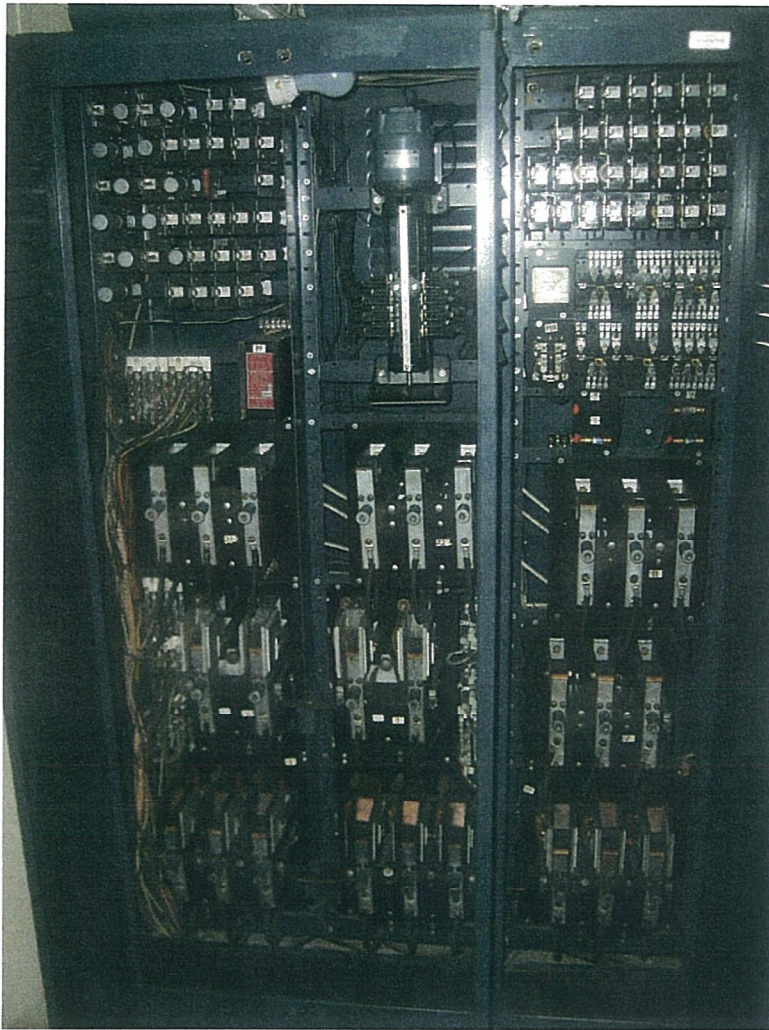
Existing Westinghouse
Elevator Controller

The existing controller equipment has exceeded its useable lifespan. Maintenance on the equipment can be labor intensive and mechanical component replacements are becoming increasingly difficult to obtain. Maintenance records obtained by CNYEC from the College indicate intermittent problems with modest component failures which indicate that reliability will continue to be a concern. A major controller component failure could cause a significant shut down for repairs which may be acceptable to the College if the car were used exclusively as a freight elevator, but would likely not be acceptable if the car were modified to be made available to the general public. Additionally, if the elevator were to be altered for passenger use the controller replacement would be required to provide code compliant door operation and fire service functions. In any case, a complete modernization of the controller equipment and door operator should be considered sooner than later.

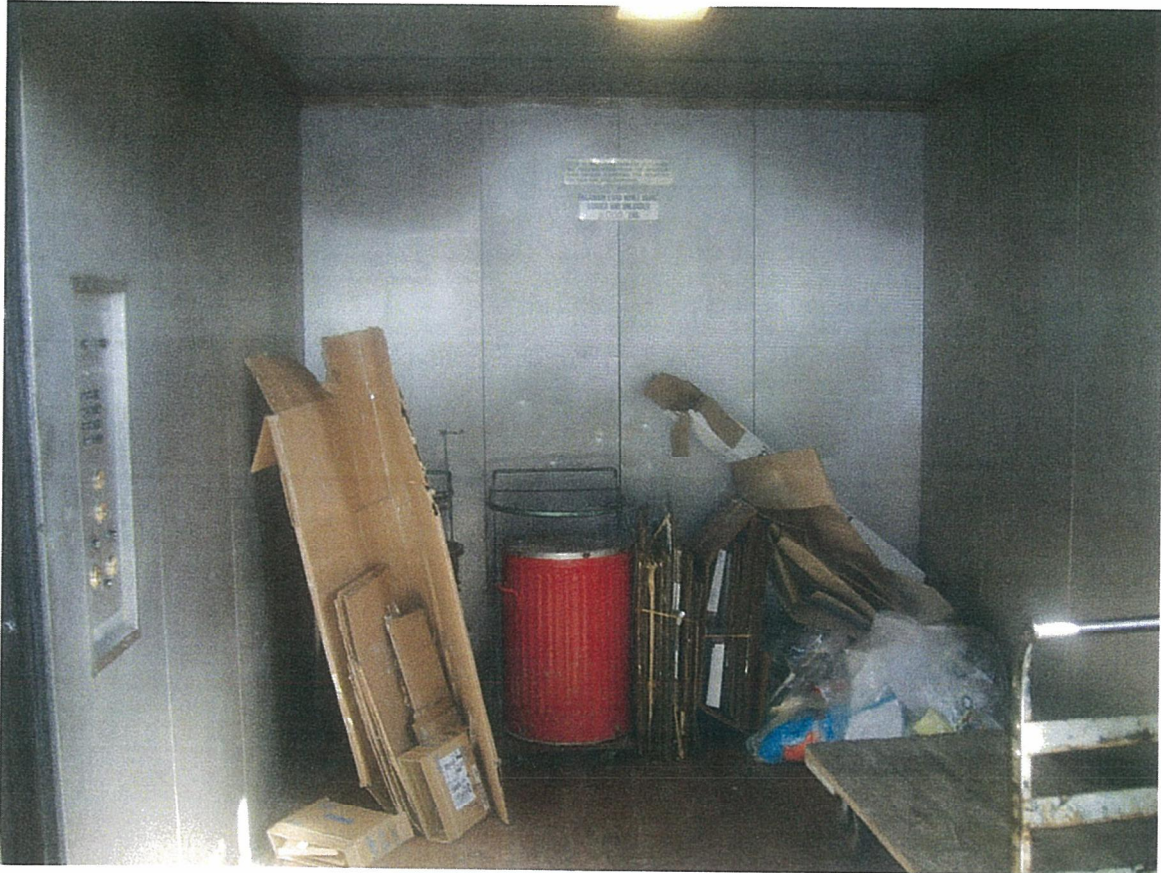
Cab

The cab finishes are a good design for a freight elevator, however if the elevator were to be used in the future as part of an accessible path the cab would have to be replaced to permit the slightly smaller platform necessary to provide adequate space for horizontally opening doors mounted inside the hoistway. If the car were replaced with a passenger service style design, it should be provided with similar finishes to the existing which are durable enough to permit continued use for material handling; however some aesthetic improvements could be included.

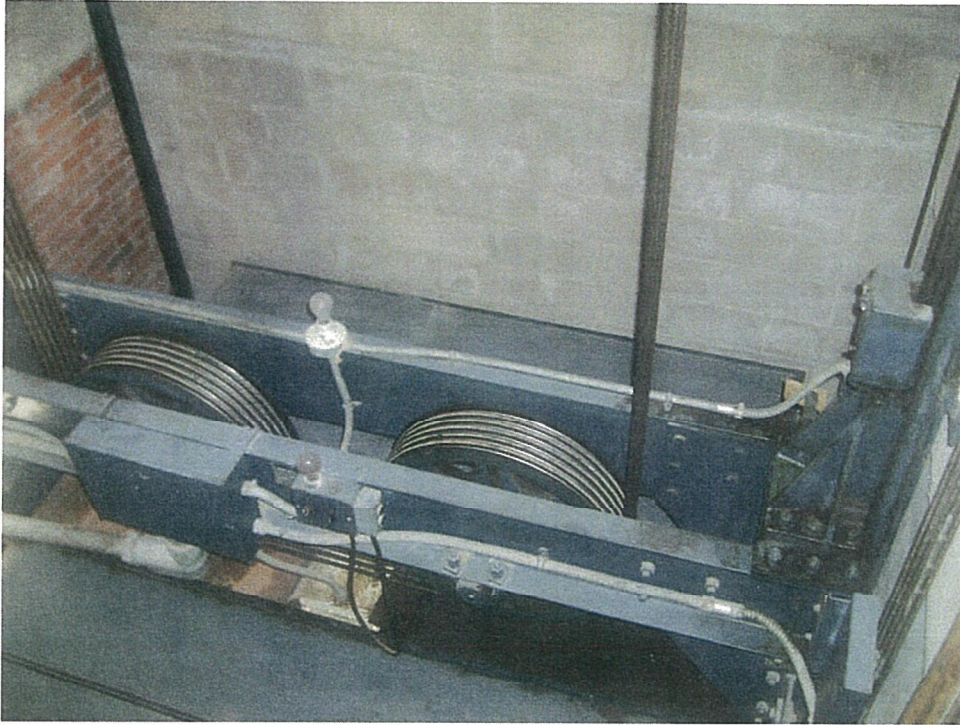
Top of Car 2:1
Roping Sheaves.

The original hoistway structural components, such as guide rails were of very durable construction and intended to last a life time. The rails and supports should be retained with the exception of the buffer support pit channel which has been damaged by rust. It may be possible that the pit channel can be retained and refurbished; however a closer inspection is required. The existing buffers should be retained. The car sling is of extra heavy duty design and should also be retained. The existing sheaves appeared to be in good condition and can be retained.
