STATE UNIVERSITY OF NEW YORK AT OSWEGO

WEST CAMPUS DINING HALL
BUILDING SHELL IMPROVEMENTS

FEASIBILITY STUDY ■ MAY 10, 2011

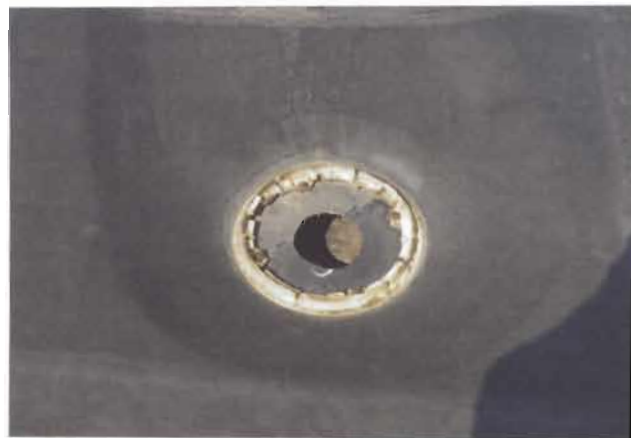
R-31-05

Drains were generally clear with adjacent tapered insulation crickets providing some drainage; however, large areas of water ponding was evident below mechanical equipment. One of the roof drains was missing a strainer cover. (See Photo R-31-05).

It is recommended that membrane and roof assembly be removed to the vapor retarder and replaced. Replace existing roof drain strainers with lockable type or cast iron to reduce the risk of blow off. Replace walkway pads with fully bonded pads and add walk pads below equipment and wiring currently draped across the membrane surface.

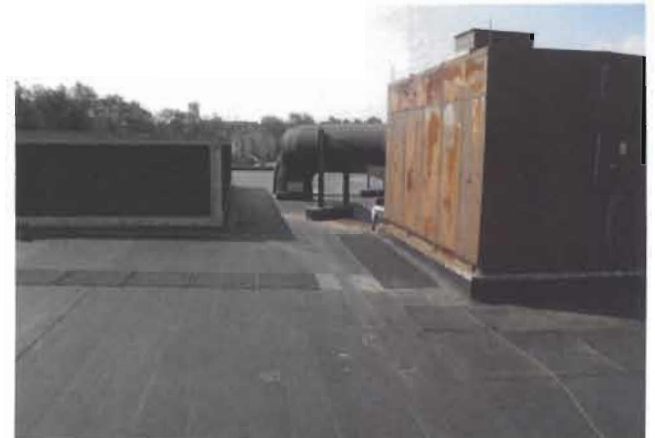
R-31-06

The metal top and sides of the large metal ventilation duct plenum on the roof are heavily rusted. (See Photo R-31-06).

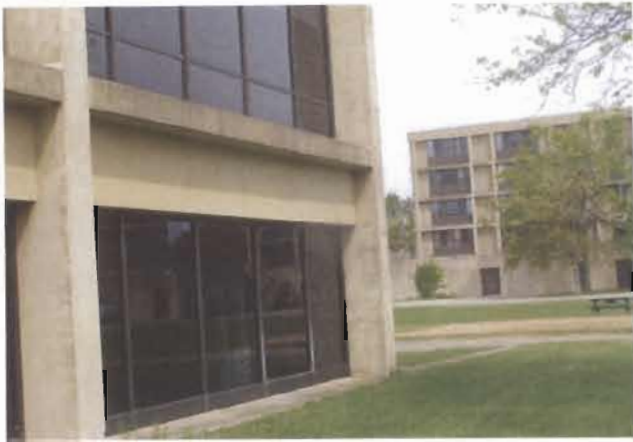
F-35-01

- Small spalls at rusted reinforcing bars - frequently beam stirrups. (See Photo F-35-01).
- There are a number of areas where the cast-in-place concrete façade surfaces have been extensively rubbed, or parged, during the original construction. Much of the surfaces have thin hairline cracking or other evidence of superficial distress. (See Photo F-35-02).

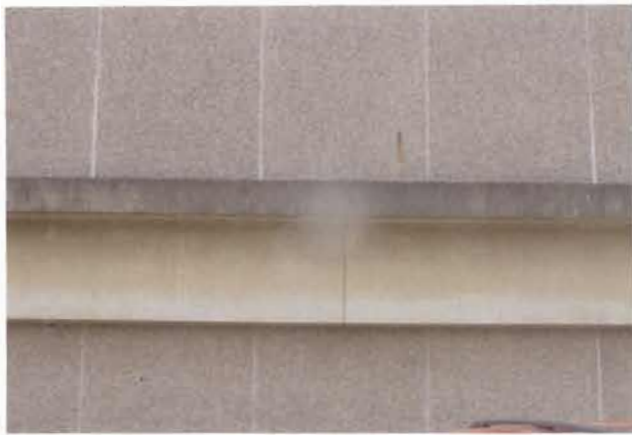
F-35-03

The rustication strips in the soffits of the spandrel beams which are transverse to the beam span, that is, perpendicular to the building façade, allow water to run from the face of the spandrel to the surface of the window wall. This is evidenced by staining of the spandrel soffit and the intersecting area of the window wall. (See Photo F-35-03).

Exposed aggregate panels are generally in good condition. On approximately 10 percent of the panels there was rust staining. This is likely due to the presence of discrete iron-rich aggregates. (See Photo F-35-03).

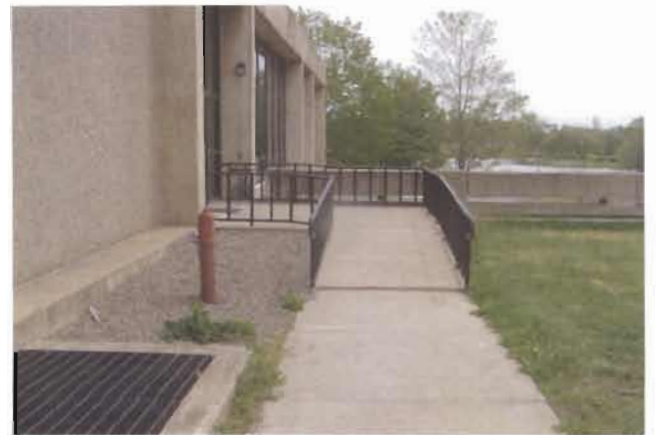
F-35-04

The concrete entrance walk at the base of the ramp on the south side upper level has settled where it abuts the concrete ramp leaving a one inch or better lip that presents a trip hazard. (See Photo F-35-04).

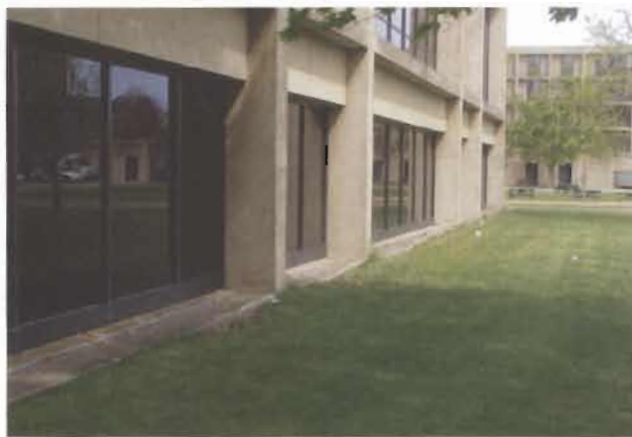
At grade along the west elevation, the concrete splash strip has settled and cracked and now slopes toward the building. (See Photos F-35-05 and F-35-06).

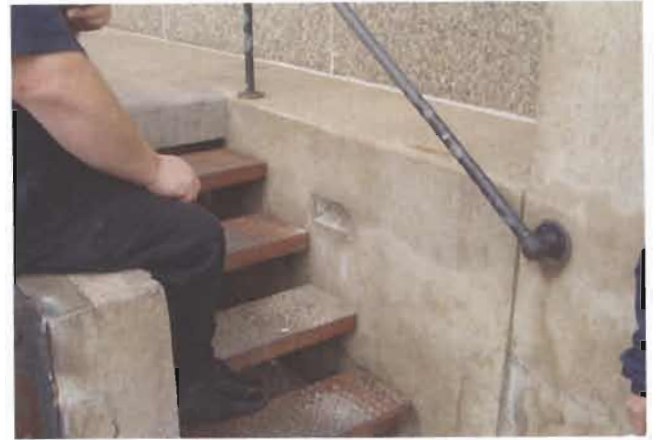
F-35-07

Loading dock stairs originally had a side light flush mounted in a recess cast into the concrete wall. The fixture box has completely corroded. (See Photo F-35-07).

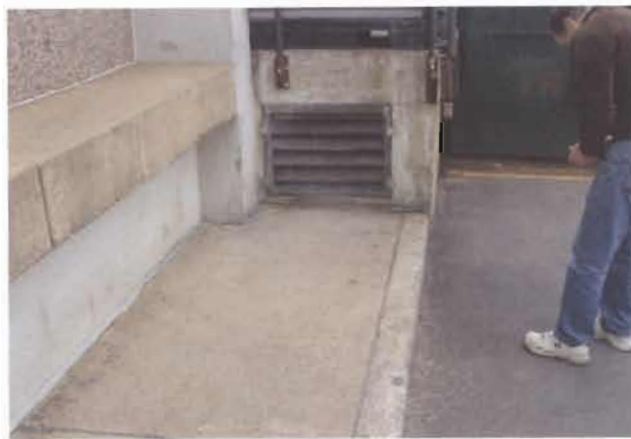
F-35-08

There is general concrete deterioration at the loading dock. A large vent grill in the north end of the loading dock would seem to support the belief that there is open space below some or all of the loading dock. (See Photo F-35-08).

The loading dock on the east side of the building is exhibiting deterioration due to environmental exposure, presumably including the application of deicing chemicals.

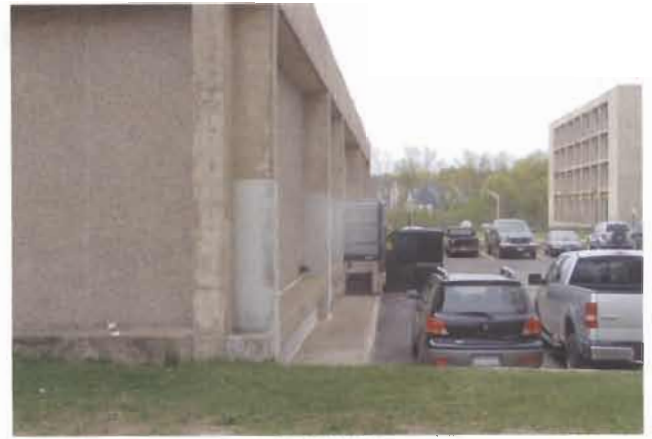
F-35-09

A gray coating or paint has been applied to the lower half of three concrete columns on the north half of the east elevation. The same coating was applied to the exposed foundation wall below the horizontal spandrel beam. (See Photo F-35-09).

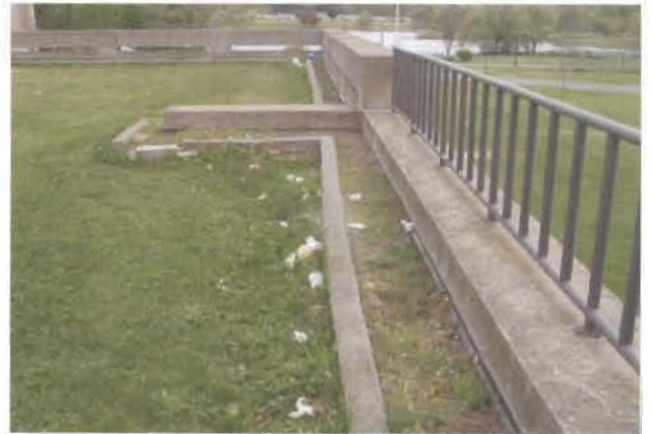
F-CT-09

There are numerous locations on the concrete façade elements where areas of the concrete surface have spalled, broken, cracked, or deteriorated. (See Photo F-CT-09).

Patch deteriorated, spalled, and missing sections of cast-in-place concrete façade. This should be done to mitigate the ongoing deterioration of the distressed areas.

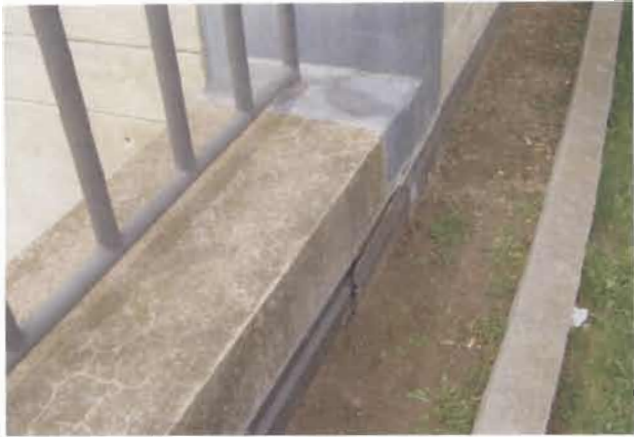
F-CT-11

Many of the concrete surfaces have thin hairline cracking or other evidence of minor surficial distress. (See Photo F-CT-11).

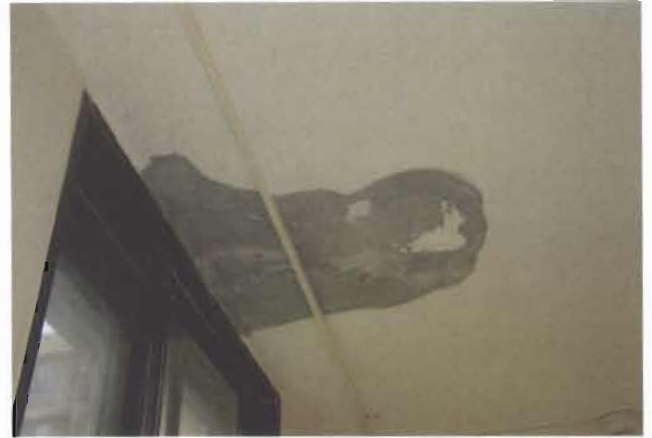
F-CT-12

The rustication strips in the soffits of the window recesses which are transverse to the facade span, that is, perpendicular to the building façade, allow water to run from the face of the facade to the surface of the window frame. This is evidenced by staining of the window soffit and the intersecting area of the window. (See Photo F-CT-12).

The transverse rustication strips at the midspan of the window head soffits deliver precipitation to the window frame, compromising the lateral drip channel rustication. This leads to staining, acceleration of soffit deterioration, and amplifies any window or sealant condition which could cause leakage.

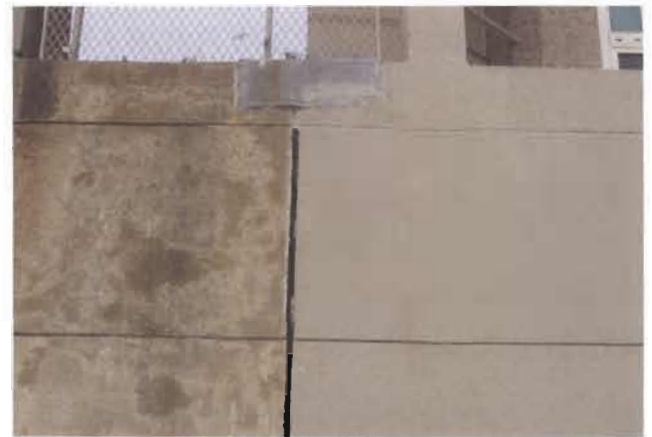
F-CT-14

Vertical movement joints between retaining walls, the tunnel connecting links and abutted buildings are all in a deteriorated state. The cap flashing on the top lacks design durability and longevity. (See Photo F-CT-14).

Repair or replace damaged and failing metal counter flashings.

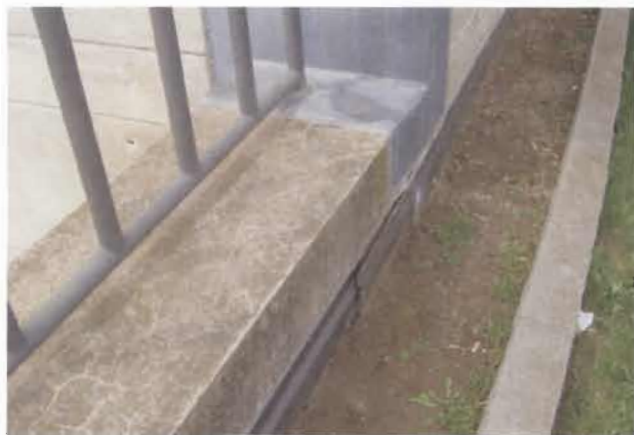
F-CT-15

Link tunnel roof membrane metal counter flashing is exposed in some areas and has come loose. (See Photo F-CT-15).
